Manhole Inspection Summary

Manhole # S09MM1033MH

Insp Date: **5/16/07 11:06 AM**

Location Address: **3345 EDGEMERE AVE**

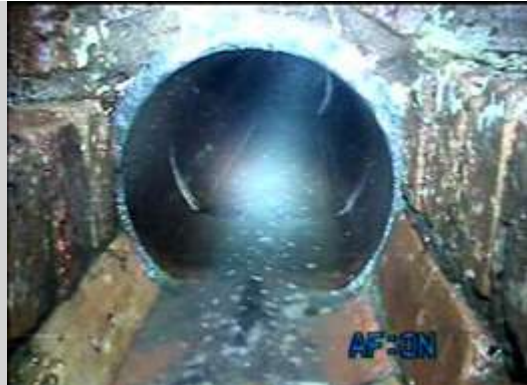
12 O'Clock Outflow

8 in. Circular Gravity Sewer
Pipe Out @ 12 O'Clock

Pipe Height: (in.) Direct
Pipe Material: **Clay** ☐ Pipe Lined
Invert Depth: **11.59** (ft.) Flow Characteristics: **Slow**
Deposits: ☒ None ☐ Mud ☐ Sludge ☐ Debris ☐ Grease
Silt Depth: (in.) Deposits Extent:
Infiltration: **None** Pipe Seal Cond: **Sound**

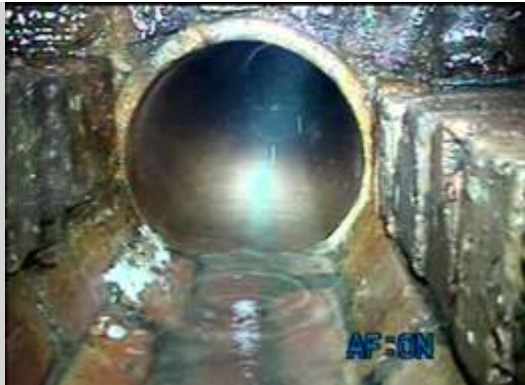
6 O'Clock Inflow

8 in. Circular Gravity Sewer

Pipe In @ 6 O'Clock

Infiltration: **None** Pipe Seal Cond: **Sound**

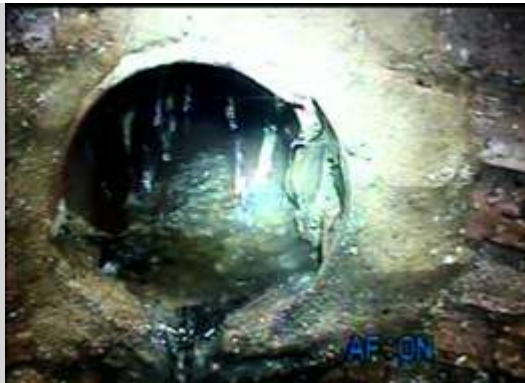
9 O'Clock Inflow

8 in. Circular Gravity Sewer

Pipe In @ 9 O'Clock

Infiltration: **None** Pipe Seal Cond: **Unknown**

Drop Condition: **Clogged**
